4 AFFECTED ENVIRONMENT, IMPACTS, AND MITIGATION

4.1 PHYSICAL ENVIRONMENT

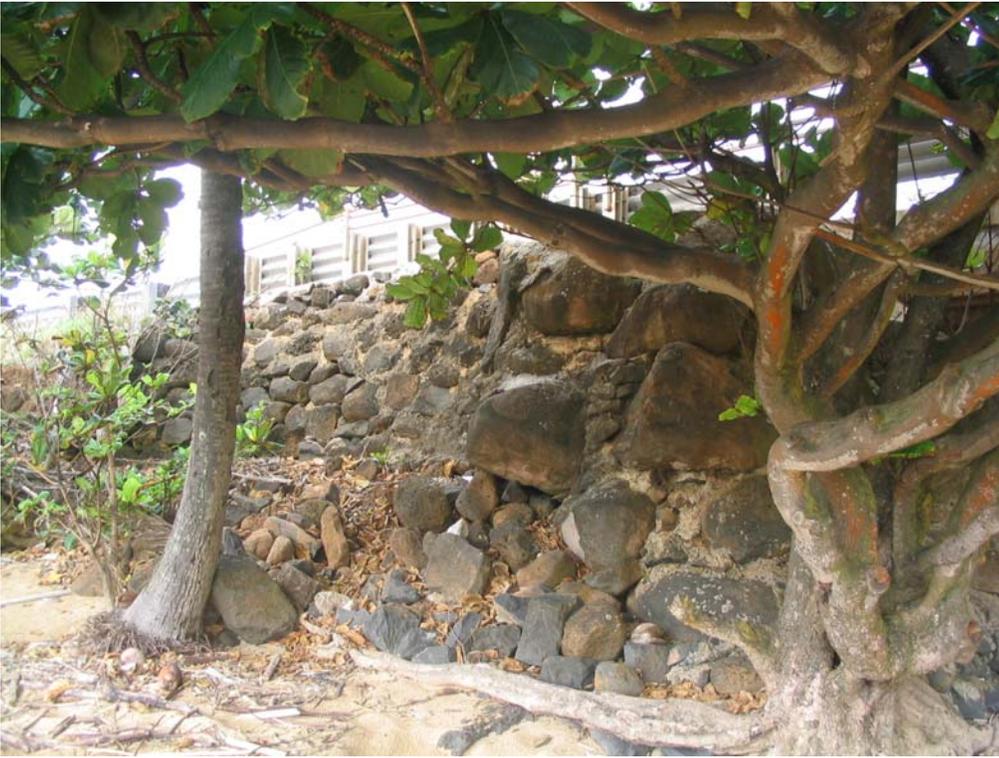
Photo 1. Revetment on South Side of Wailua River Bridge.

The proposed path begins at the existing bike/pedestrian path cul-de-sac near the Aloha Beach Resort and moves north where it meets and follows Kūhiō Highway along the bridge that spans the Wailua River. The river on the south runs approximately perpendicular to the road, which is at a higher elevation than the riverbank. Approaching the river, the strip of land along the road becomes increasingly narrow and a revetment has been constructed to stabilize the bank (Photo 1). The slope adjacent to the revetment on the south is stabilized by vegetation, including trees and naupaka. The bridge itself shows signs of repair. There are numerous visible areas of restoration, including gunite patches (Photo 2). An overview of the area and photo locations are shown in Figure 10.

Initially, there will be enough land to construct the shared use path in the same manner as the existing concrete path. Starting approximately 200 feet south of the Wailua River cane haul bridge, the shoulder becomes too narrow and the path will have to be elevated over the bank, through and above the existing vegetation. The bike path is then proposed to cross the river as a structure cantilevered to the cane haul bridge.

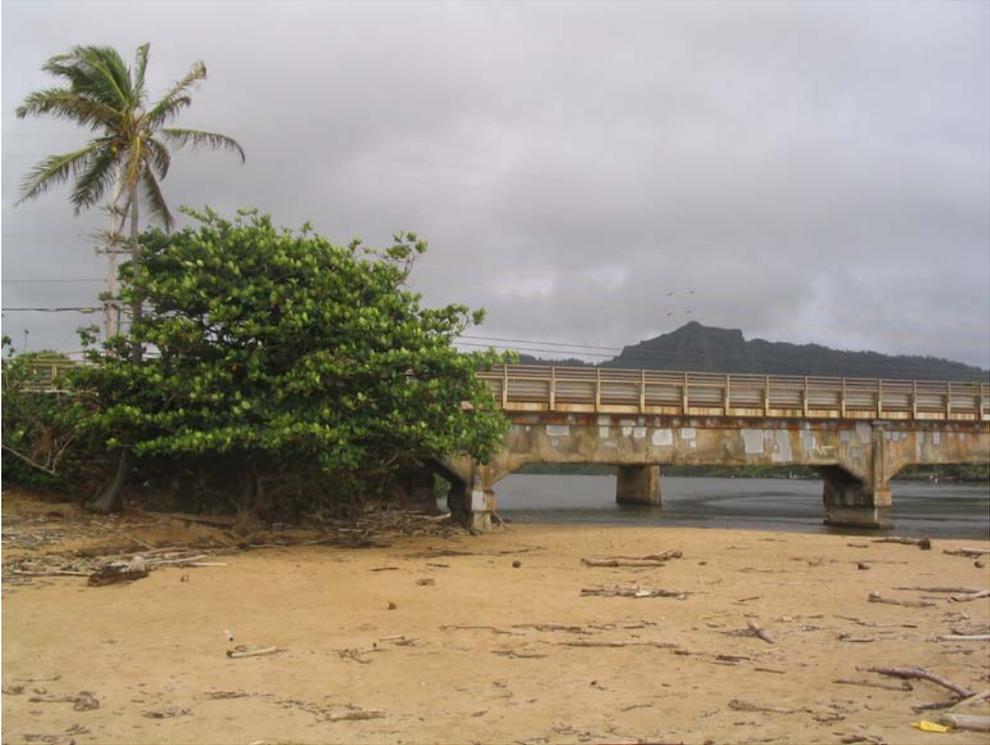
Photo 2. Wailua River Bridge.

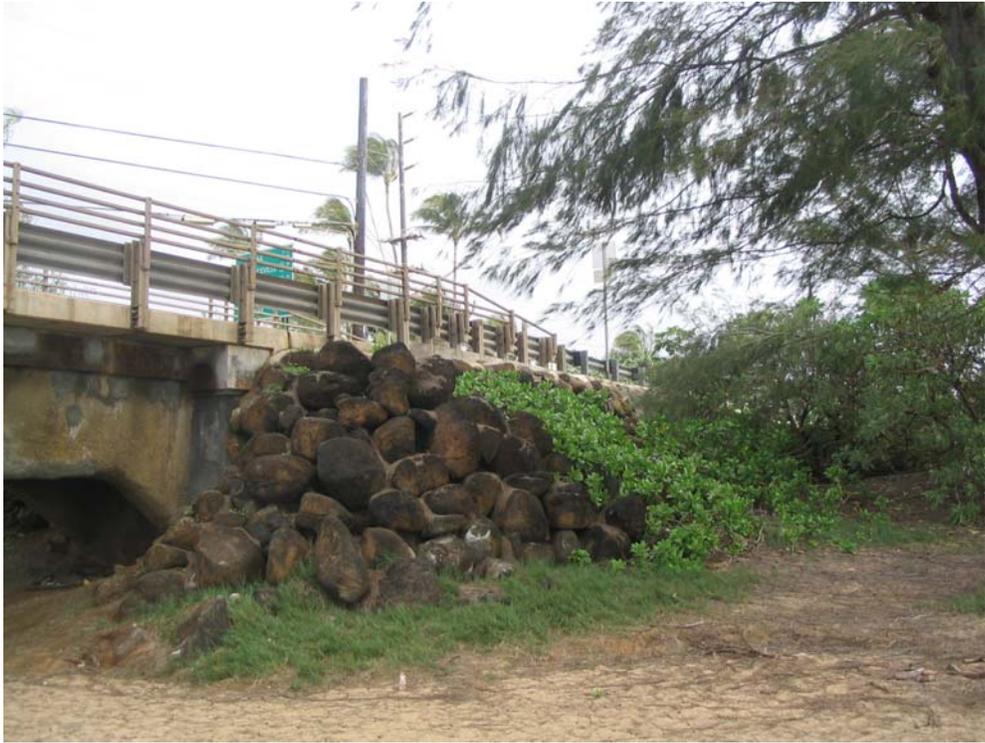
Photo 3. Revetment on North side of Wailua River.

The north side of the Wailua River cane haul bridge is supported in a manner similar to the south side and transitions into a vegetation-stabilized bank (Photo 3). The road elevation decreases and the slope from the road becomes gentler. The beach here is quite wide and the back beach area is well vegetated with beach morning glory and naupaka. A low uncemented rock wall stabilizes the shoulder of the road (Photo 4), which is located 125 to 225 feet inland of the shoreline. The wall transitions into an approximately 3.5-foot high vertical Cement Rubble Masonry (CRM) wall that runs along the shoulder of the road (Photo 5).

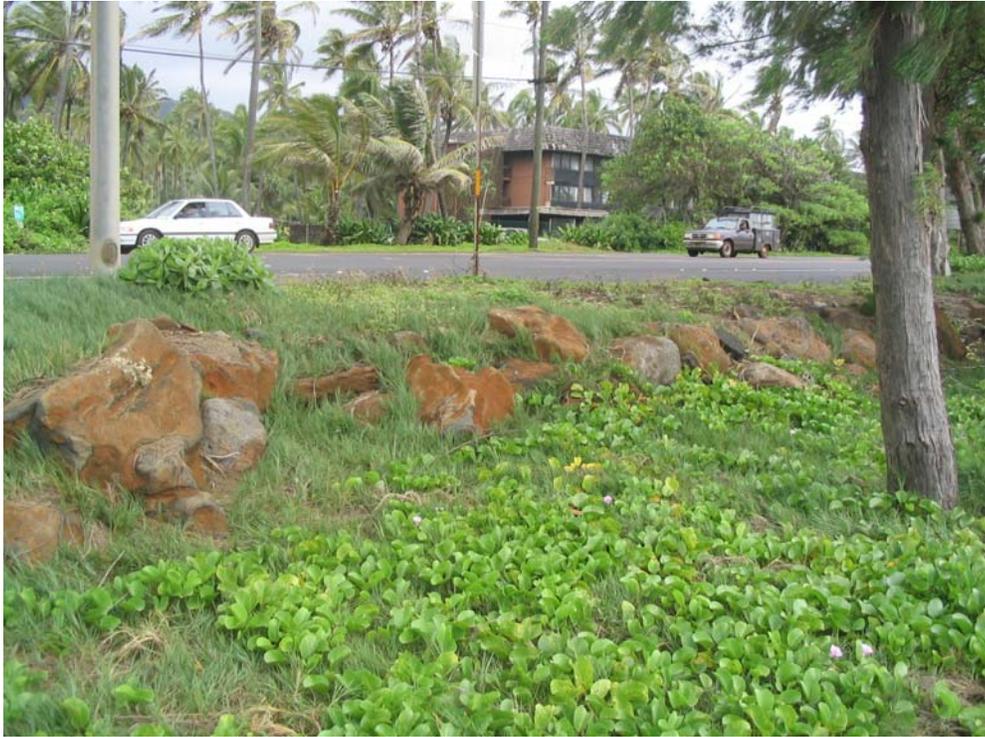
Photo 4. Uncemented Rock Wall and Beach Vegetation along Kuhio Highway.

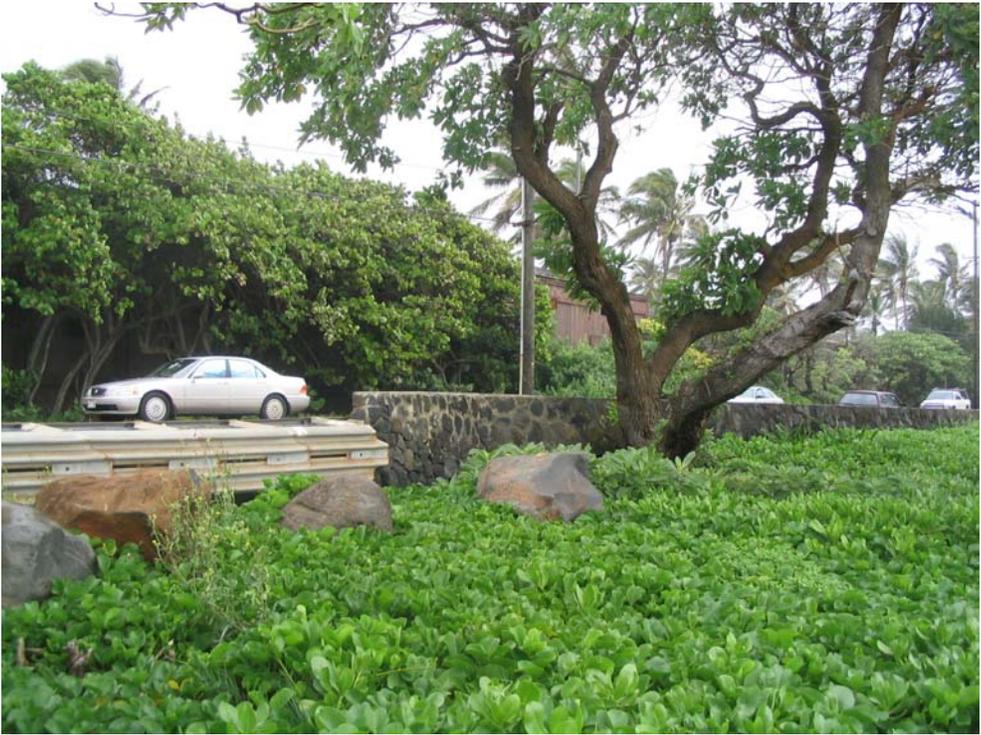
Photo 5. Transition from Uncemented Wall to CRM Wall.

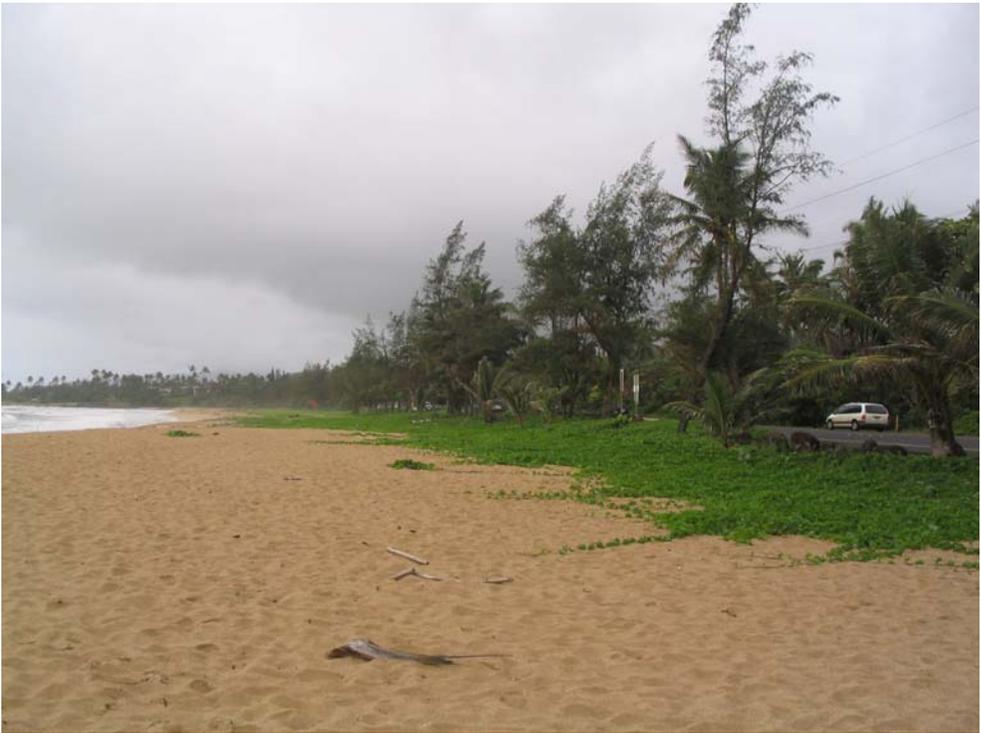
Photo 6. Wailua Beach.

Wailua Beach is about 2,000 feet in length, measured from the Wailua River to the Seashell Restaurant and appears to be stable. The coral reef offshore of Wailua Beach is not extensive and waves break very close to shore, as can be seen in Figure 10. The beach (Photo 6) is typically more than 100 feet wide and has a history of accretion. Figures 11 and 12 present the results of an aerial photographic analysis of shoreline erosion in the area (Makai Ocean Engineering and Sea Engineering, 1991). From 1950 to 1988, there were increases of 30 and 40 feet at Transects 21 and 22, respectively, across from the Coco Palms Hotel.

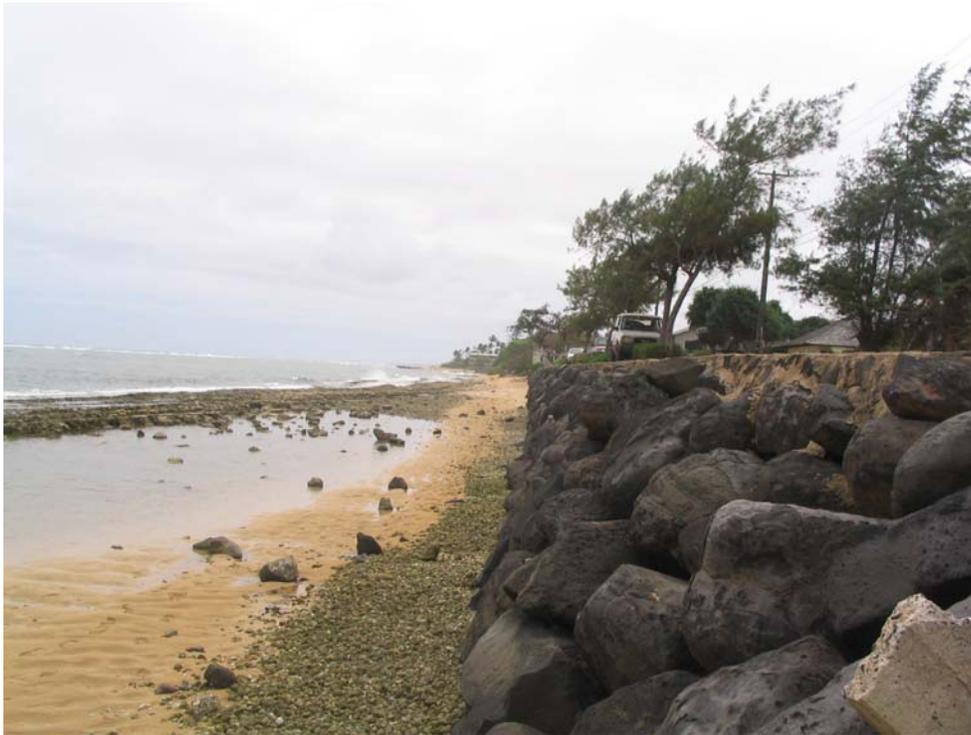
Photo 7. Revetment at Moanakai Road.

The proposed path contains another coastal section where it travels along Moanakai Road to Waikaea Canal, the project end point. A 900-foot long revetment stabilizes the southern portion of Moanakai Road, beginning near the intersection of Moanakai Road and Keaka Road (see Figure 14). The face of the revetment is slightly steeper than 1V:1H (Photo 7) and a grout cap provides a walkway (Photo 8). The road is two-way and parallel parking is allowed between the road and the revetment. The beach fronting the revetment is heavily eroded. The beach is narrow and beach rock is exposed at low tide. Further north, the revetment has a gentler sloping face and no cap, and then ends 1100 feet south of Waika‘ea Canal (Photo 9). The beach and back beach areas widen from this point to the Waika‘ea Canal and the waterline extends up to 125 feet from the road. Moanakai Road ends approximately 400 feet south of the canal. The offshore area contains a low, flat reef that extends 600 feet from shore.

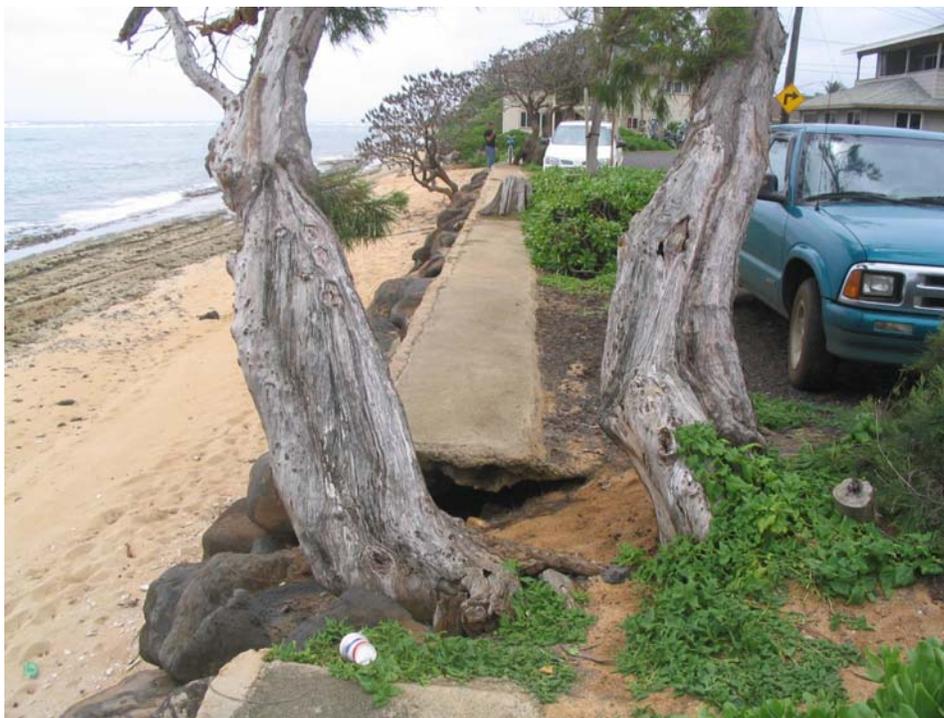
Photo 8. Revetment and Grout Cap at Moanakai Road.

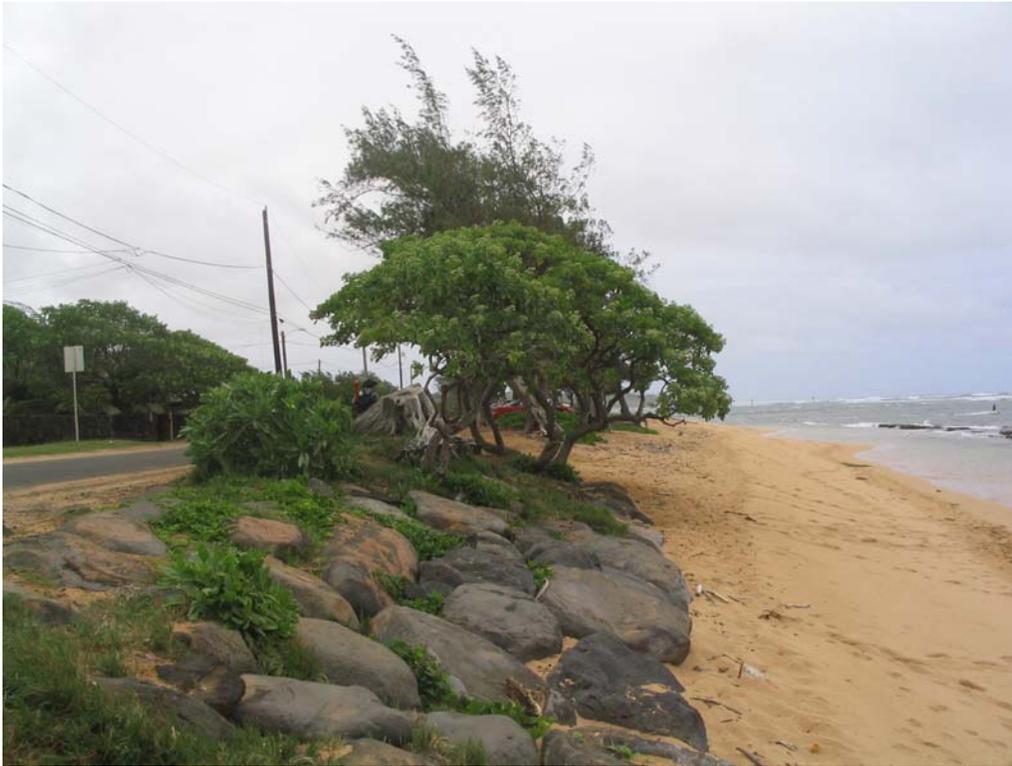
Photo 9. Sloping Revetment at Moanakai Road.

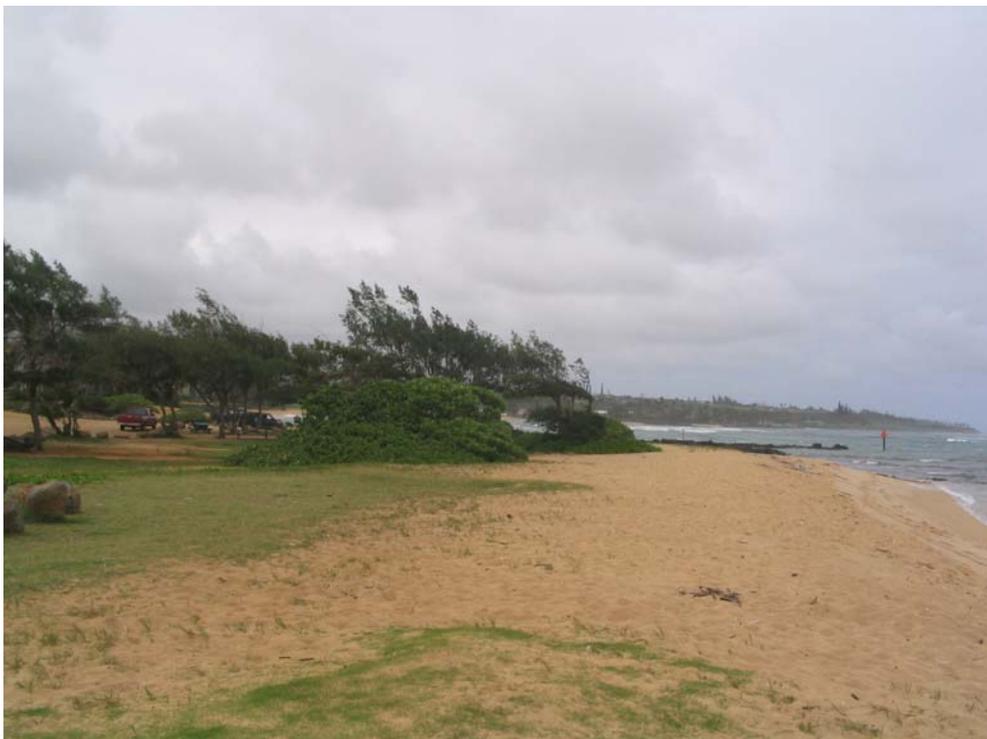
Photo 10. Vegetation near End of Moanakai Road.

Past the end of the road and entering Lihi Park, the path meanders inland, mauka of the vegetation (Photo 10), and around the parking area to the footbridge across Waika‘ea Canal.
